NASA Contractor Report 178246

Test Results for Composite Specimens and Elements Containing Joints and Cutouts

**Douglas Aircraft Company
McDonnell Douglas Corporation
Long Beach, CA 90846**

August 1988

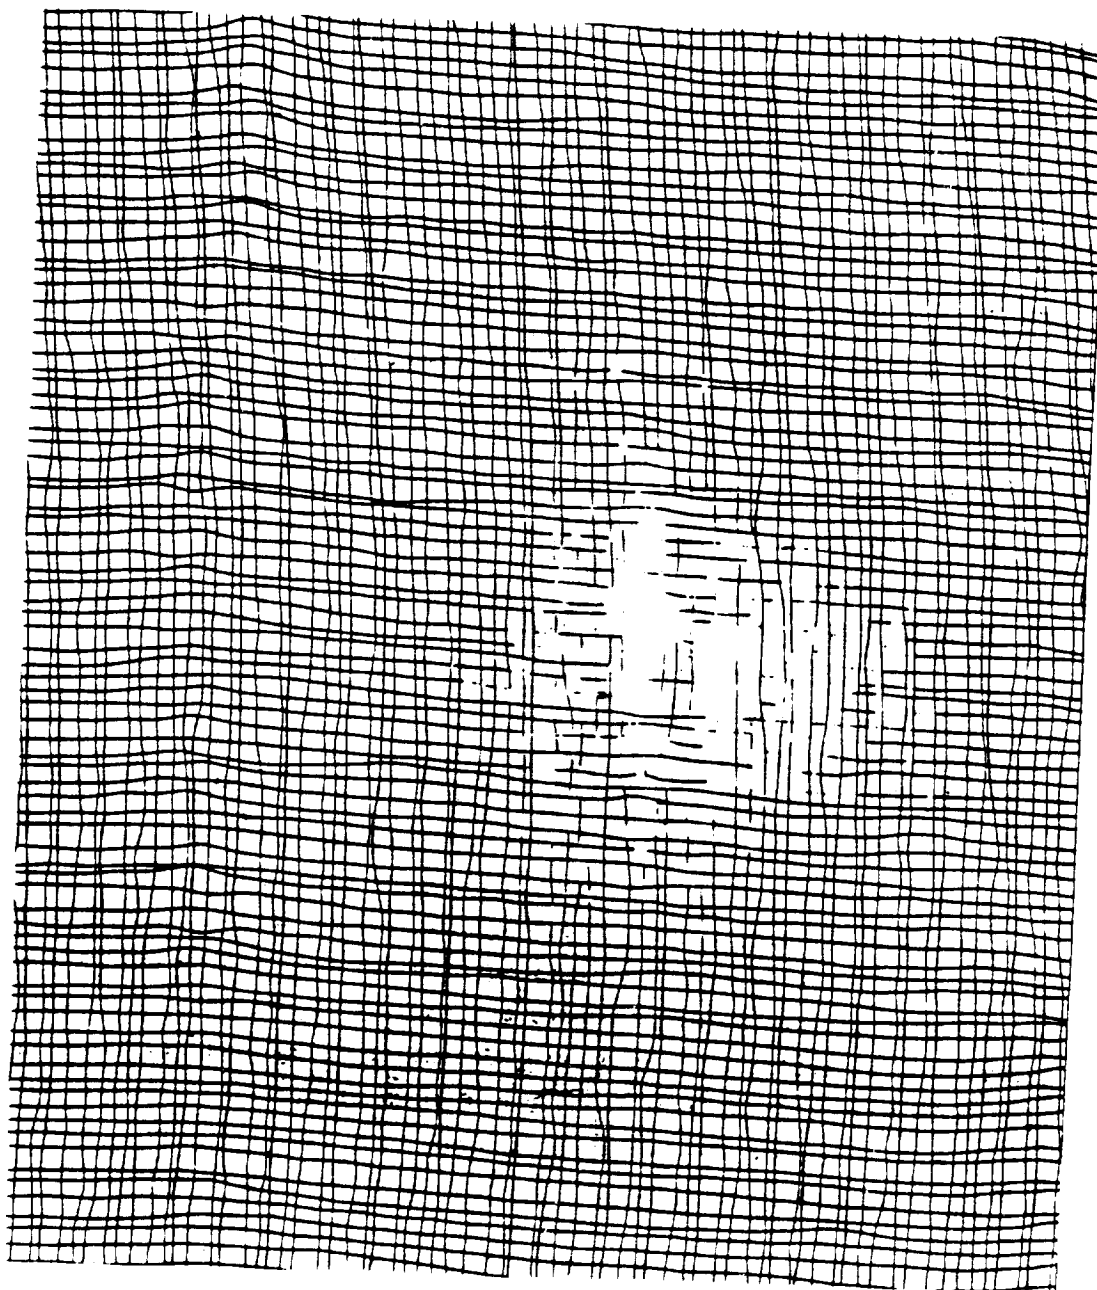
Figure 4-6. X-Ray of -507 CAI Specimen Showing Damage to Aluminum Wires

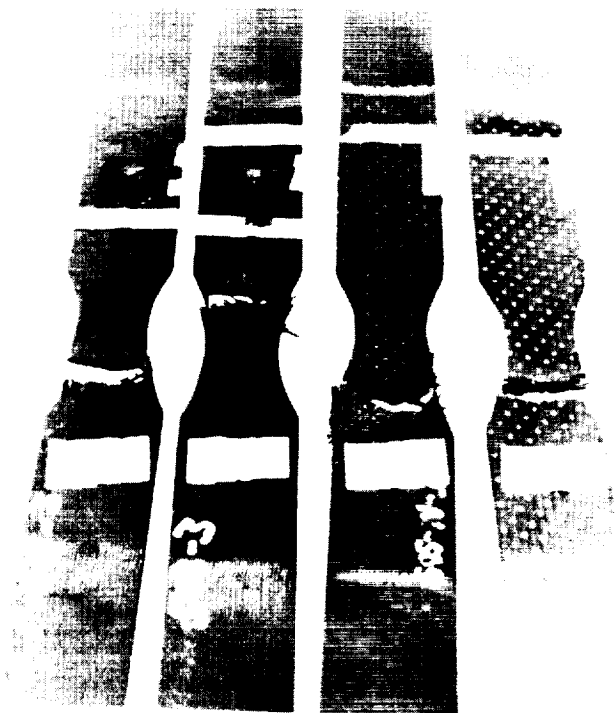
Two sets of unnotched tension specimens were fabricated and tested. The original specimens were “dog-boned” in an attempt to avoid failures at the grips of the test machine. None of these specimens, however, actually failed at the minimum cross section (Figure 5-3). The redesigned specimens were simply 7.50-inch by 1.12-inch strips with no dogbone or doublers. It was observed that there was only a slight increase in the ultimate tension strength of lay-ups No. 2, 3, and 4. Lay-up No. 1, however, showed a substantial increase in strength of just over 37 percent. In an attempt to reconcile this discrepancy, specimens from both sets were inspected for thickness, ply count, and ply orientation, but no anomalies were discovered.

Figure 5-3. Failures of the Dogboned UNT Specimens

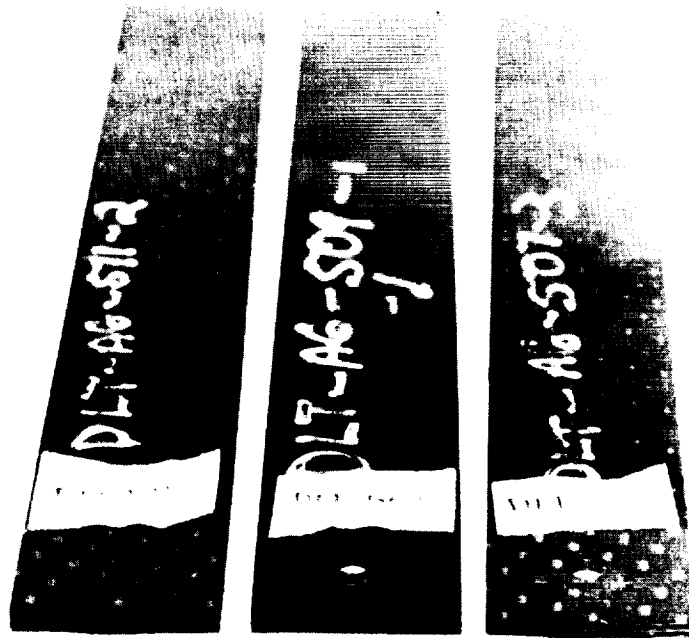
Figure 5-6. Bearing and Shear-Out Failures of Wide DLT Specimens ($W/D = 6$)

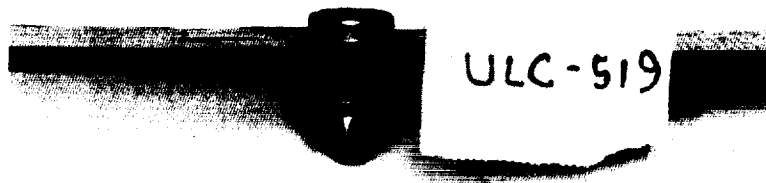
Figure 5-9. Typical Failure of ULC Specimen with 3/16-Inch Fastener (Lay-Up No. 4)

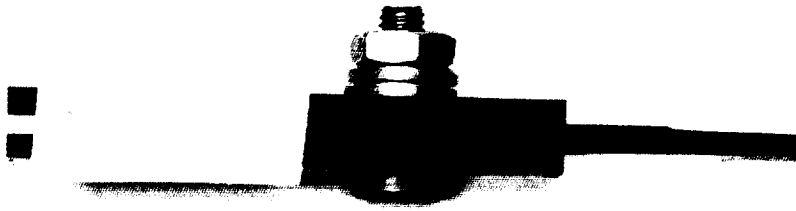
Figure 5-11. Typical Failure of Narrow DLC Specimen (Lay-Up No. 2)

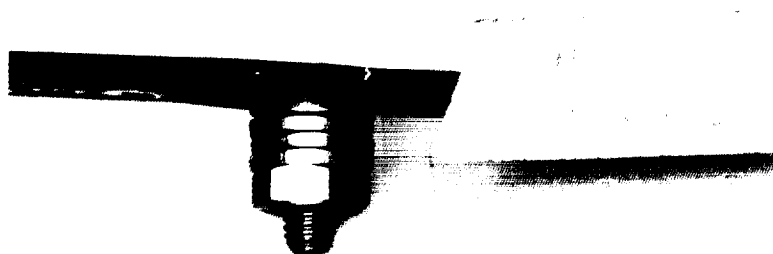
Figure 5-15. Typical Failure of Countersunk ULC Specimen (Tested With Fastener)

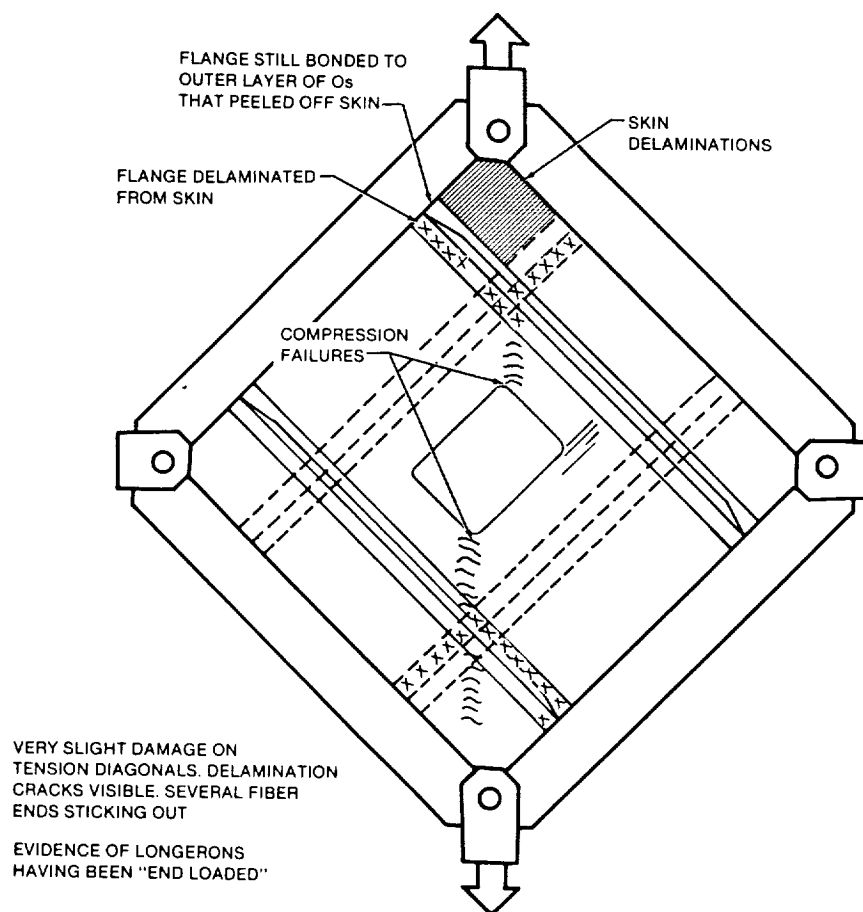
As noted in Figure 5-26, there was also some very slight damage observed on the tension diagonals, as well as some slight brooming at the ends of the stiffeners, indicating that they had been end-loaded by the thick steel doublers bonded to the periphery of the panel. The loads carried by the latter, however, are not considered to have been significant.

Figure 5-26. Failure Locations for -501 Shear Cutout Panel

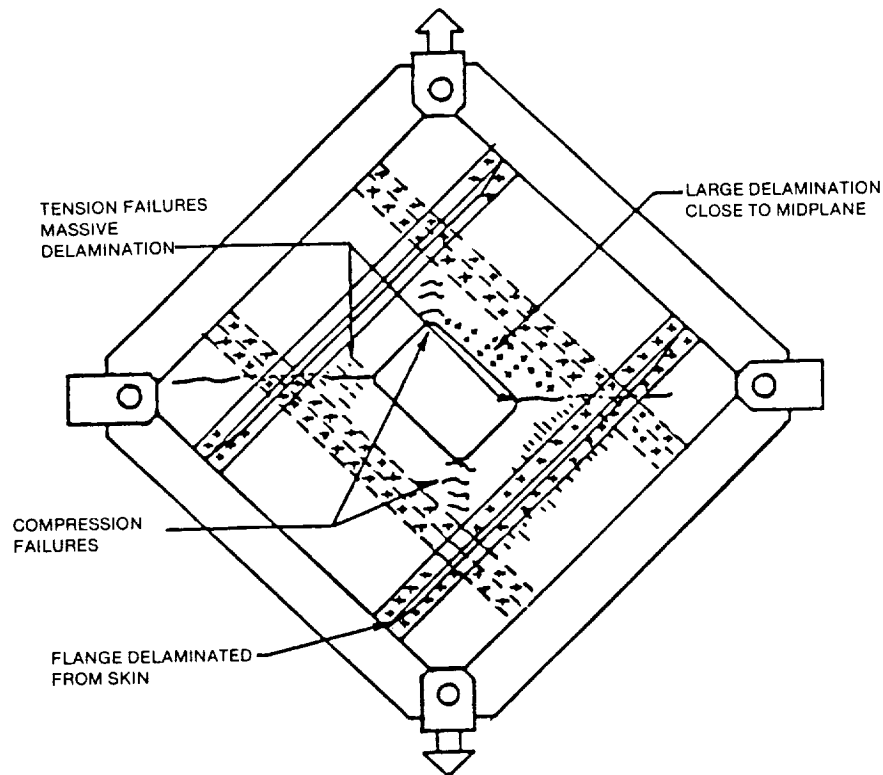
Figure 5-28 is a sketch of the softened panel (-503) after failure. Strain gage data taken at the bottom corner indicate roughly linear behavior to about 60 kips. At 70 kips, measured strains at the bottom corner began to drop off rapidly with increasing load (down from $-11,629 \mu\text{in./in.}$ at 70 kips to $-5,360 \mu\text{in./in.}$ at 80 kips). Visual examination revealed very localized delaminations in both compression corners. These delaminations occurred on the side of the panel with the photoelastic film only a few layers from the outside surface. They were also located very close to the points of tangency of the corner radii to the straight sides. The load was then increased to 100 kips. Unlike the -501 (baseline) panel, very little growth of the delaminations was detected as the loads were increased to panel failure, which occurred at 121,110 pounds.

Figure 5-28. Failure Locations for -503 Shear Cutout Panel

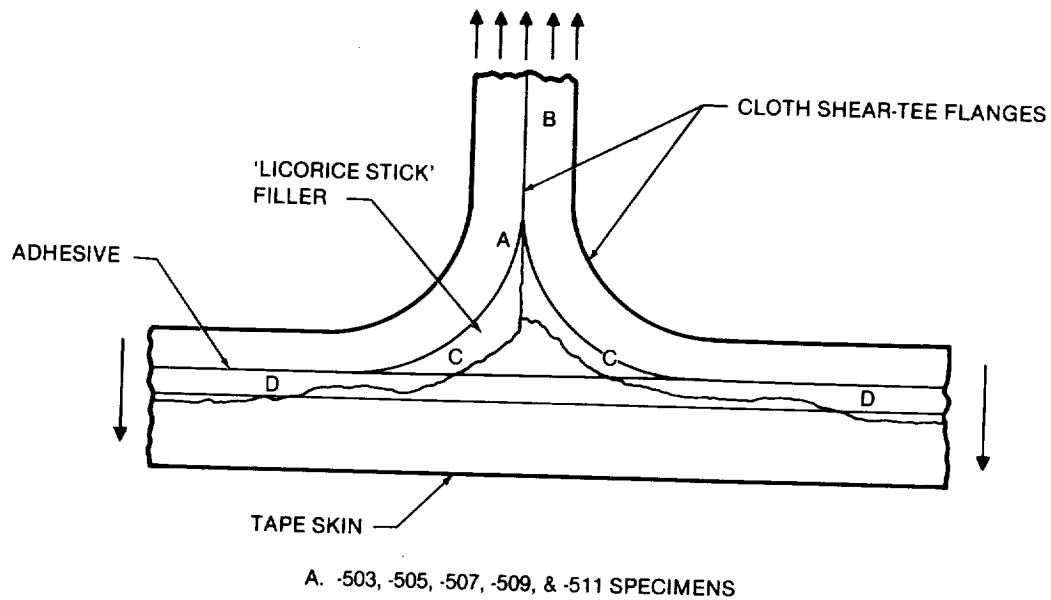
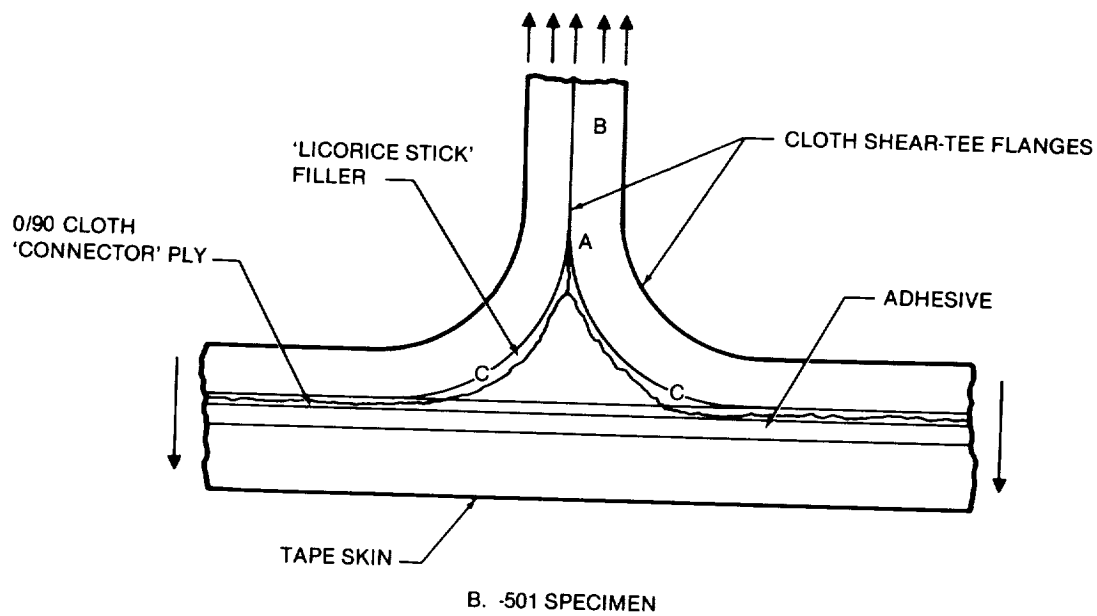
Figure 5-30. Apparent Failure Sequence for Shear-Tee Pull-Off Specimens

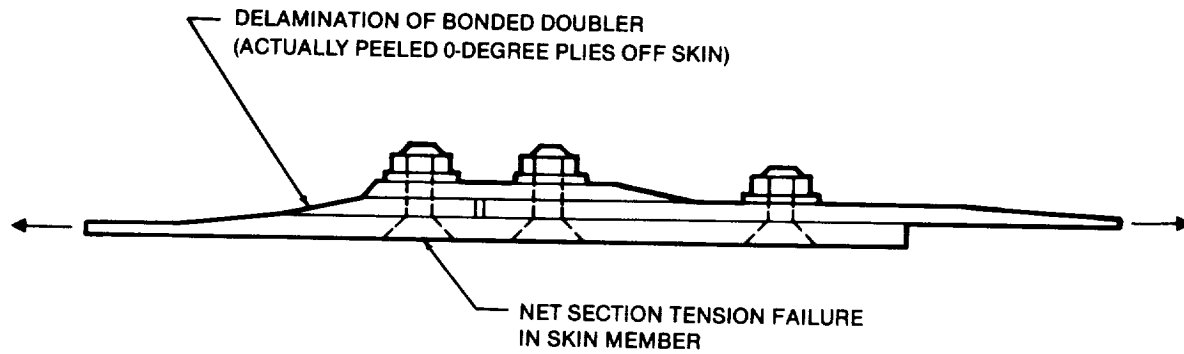
Figure 5-32. Failure Mode of Tailored Longitudinal Splice Specimens

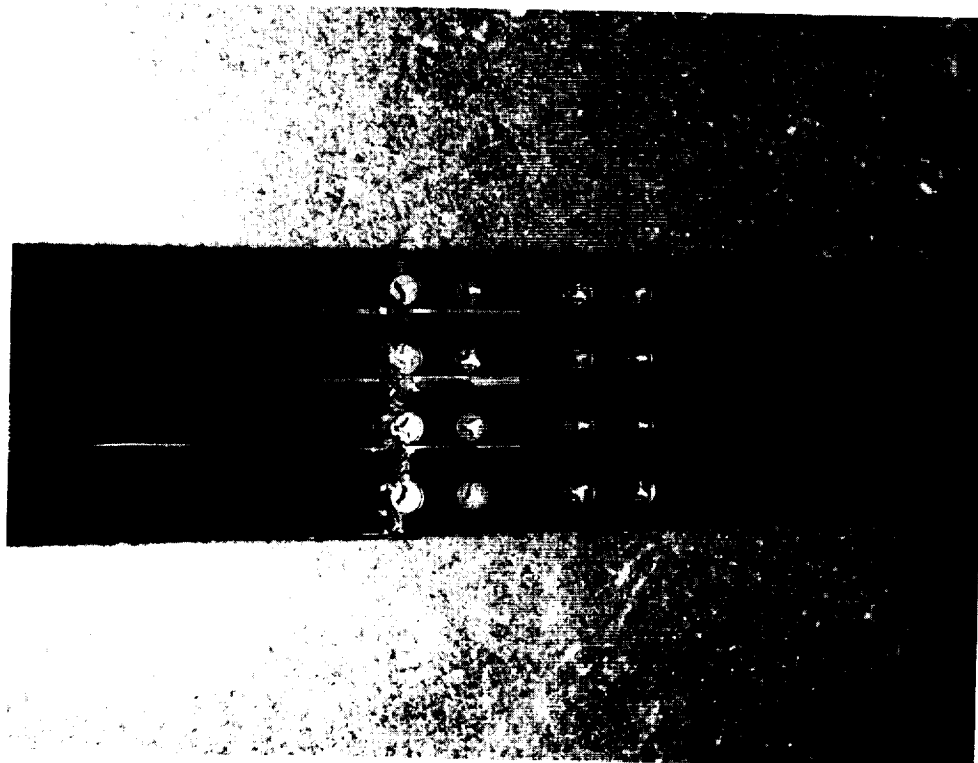
Figure 5-33 shows the failed baseline transverse skin splice specimen. The failure mode was net-section tension through the countersunk skin at one of the outermost rows of fasteners. Fastener rotation and bearing damage was minimal at the other three rows. This was typical of the two specimens assembled without sealant. The failed -1 specimen (assembled with sealant) appeared quite different, however. The ultimate failure apparently was partially tension through the outermost row of fasteners, and partially a combination of fastener failure and fastener pull-through. In addition, all four rows of fasteners exhibited significant fastener rotation with the accompanying bearing damage.

Figure 5-33. Failed Baseline Transverse Skin Splice Specimen

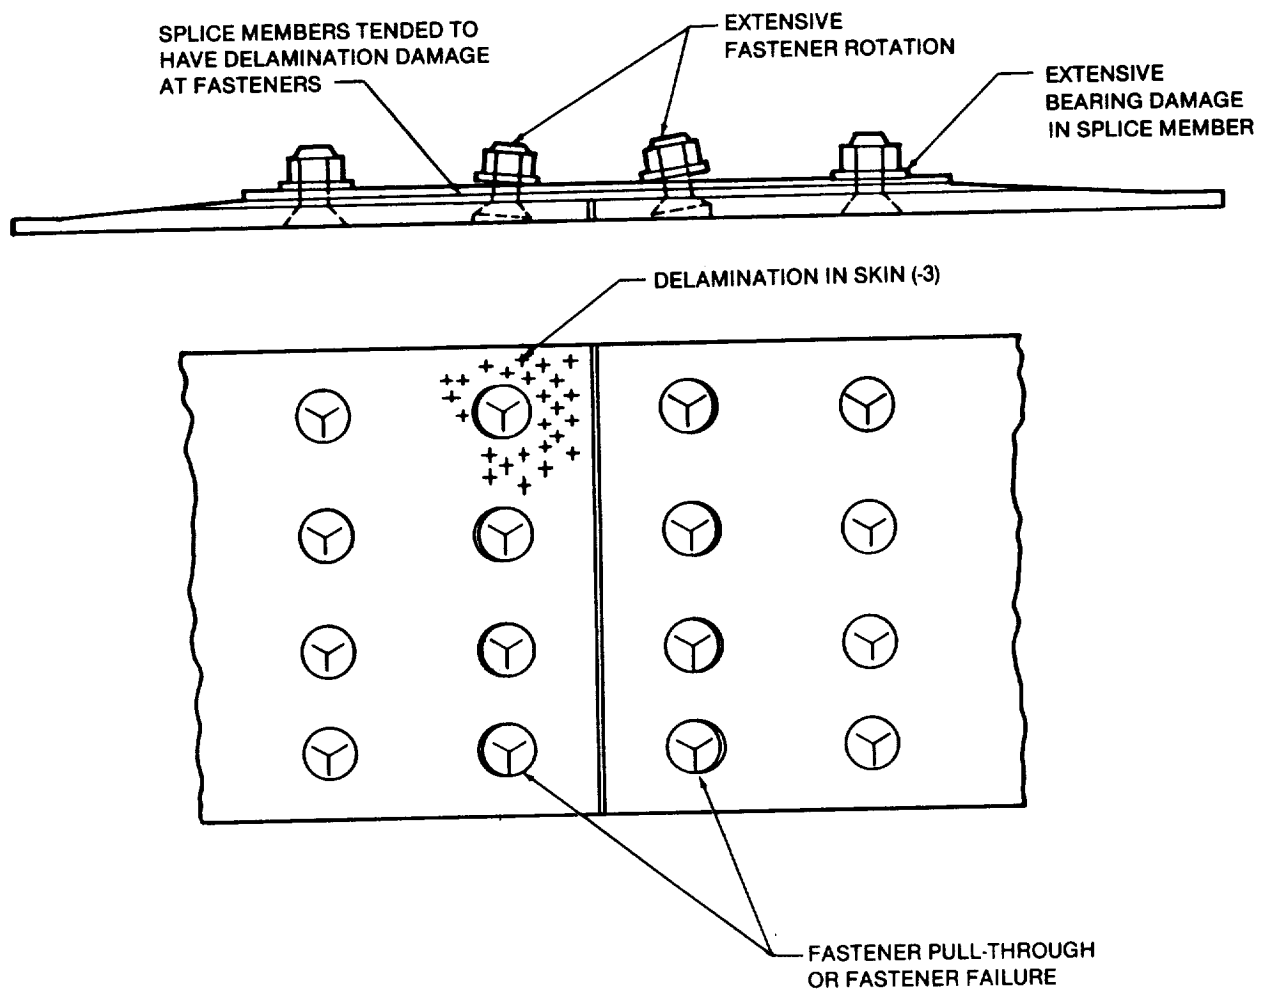
The presence of the sealant (for the -1 specimen) significantly reduced the strength of the tailored transverse splice specimen. The failure mode, for the most part, appears very similar to that of the -2 and -3 specimens (i.e., extensive bearing damage in the splice member at the outside rows of fasteners with the ultimate failure occurring at one of the inside rows due to fastener failure). Fastener failure for the specimens tested without sealant always occurred at the fastener head, through the tri-wing recess. Fastener failures for the -1 specimen, however, occurred at the opposite end near the first thread.

Figure 5-34. Failure Mode for Tailored Transverse Skin Splice Specimens

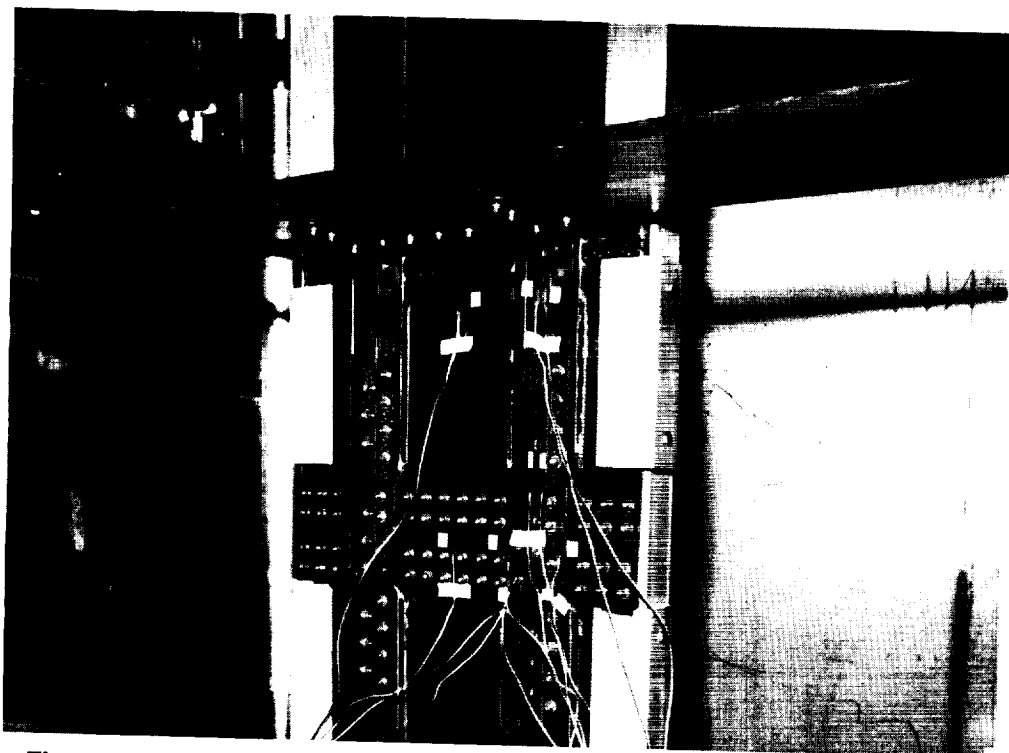
Figure 5-41. Failure of Longeron/Skin Splice Panel (Compression Specimen)

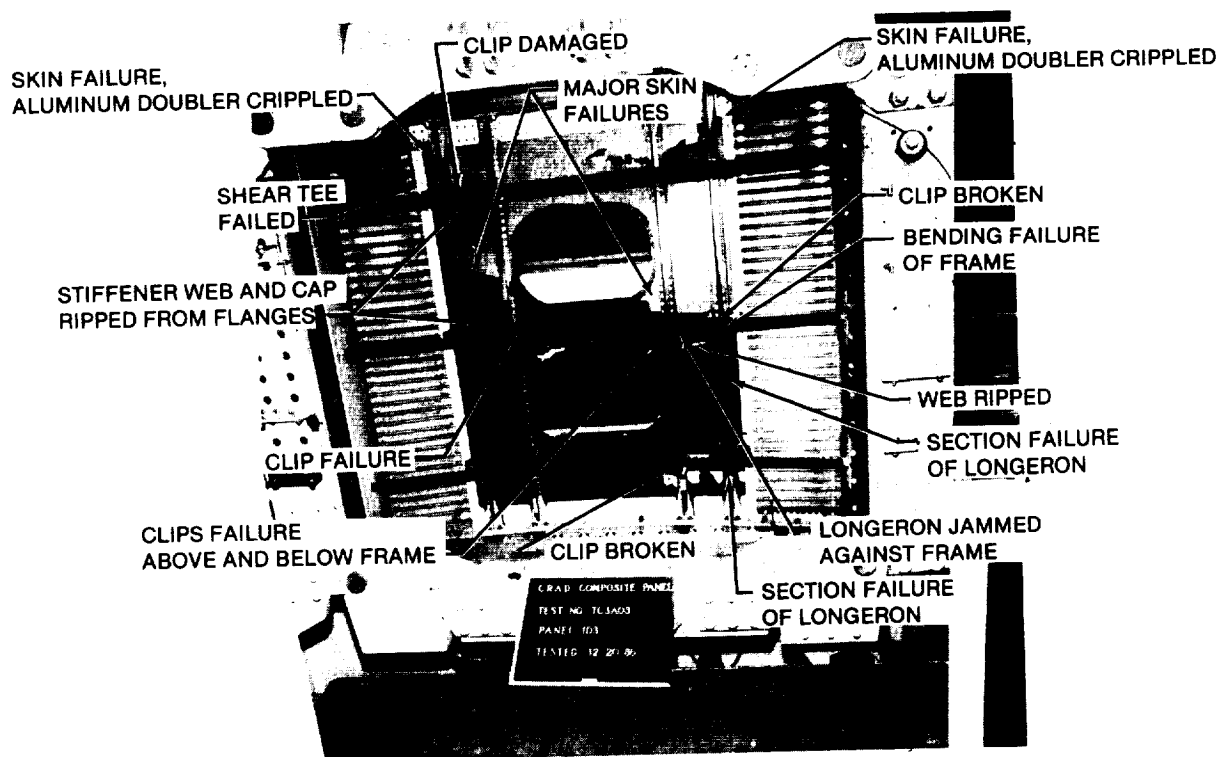
Figure 5-46. Group D Window Belt Panel Showing Failure Locations

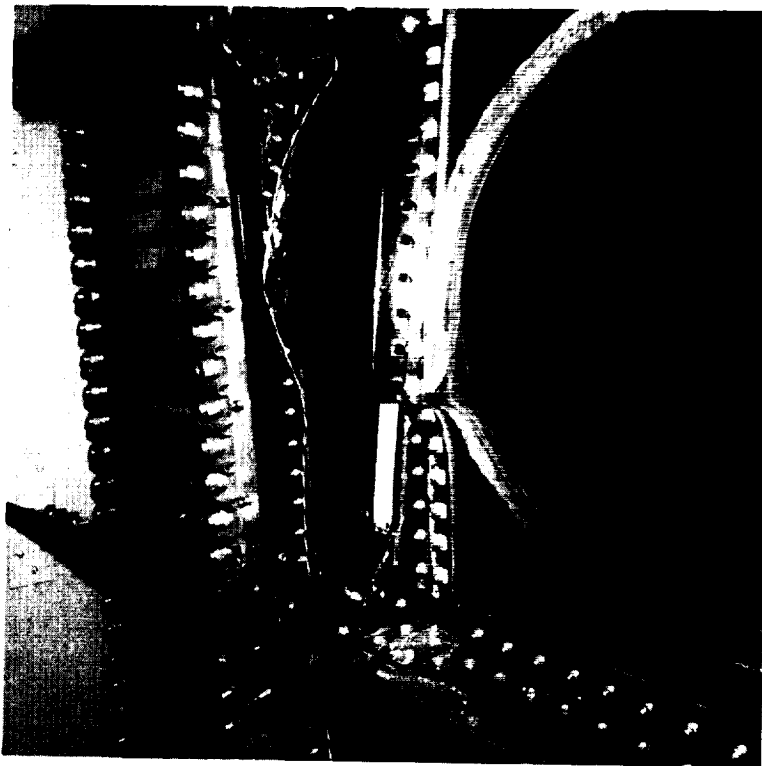
Figure 5-47. Group D Window Belt Panel — Area of Initial Failure

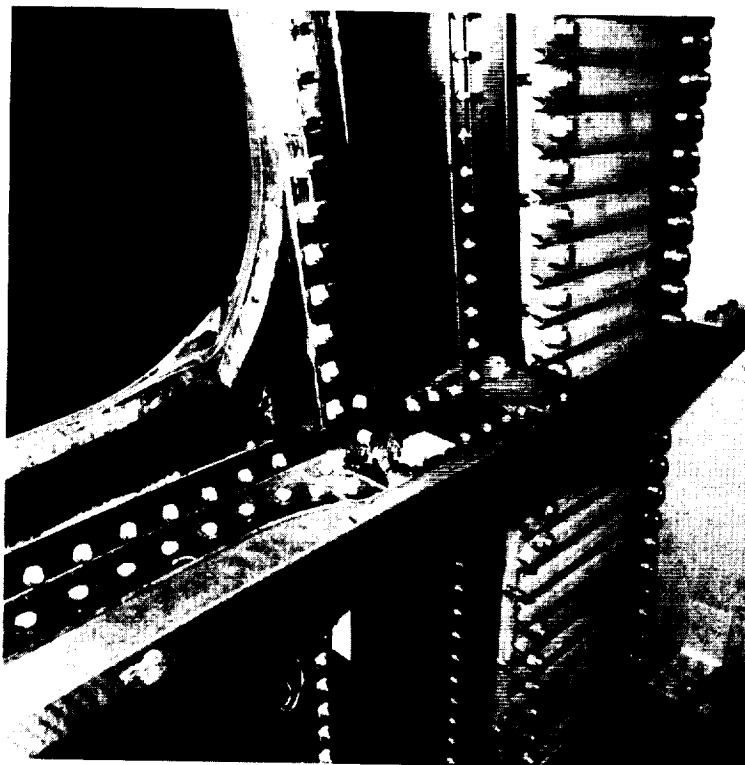
Figure 5-48. Group D Window Belt Panel — Failure of Skin, Longerons, and Frame

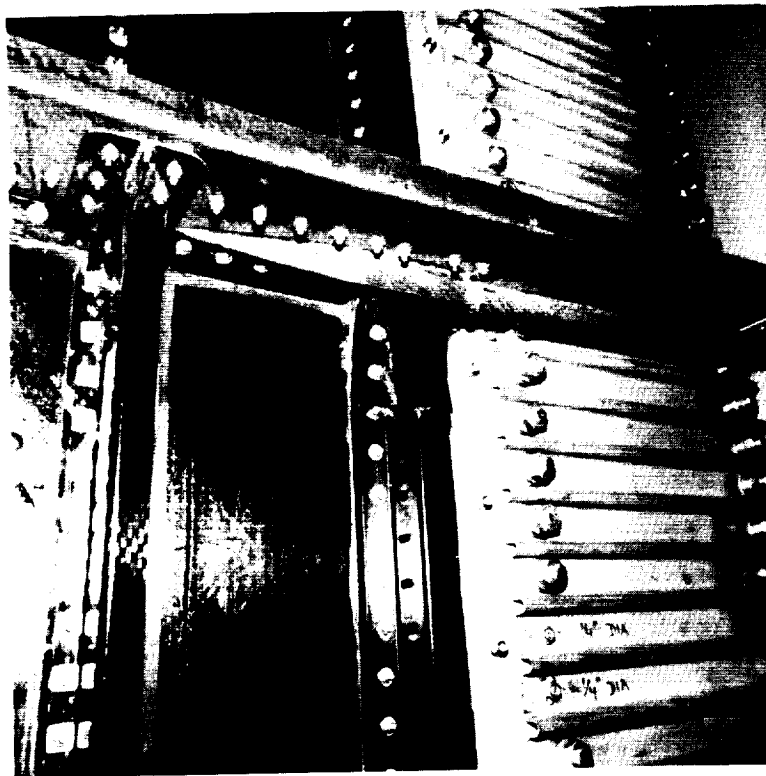
Figure 5-49. Group D Window Belt Panel — Failure of Skin, Longerons, and Frame

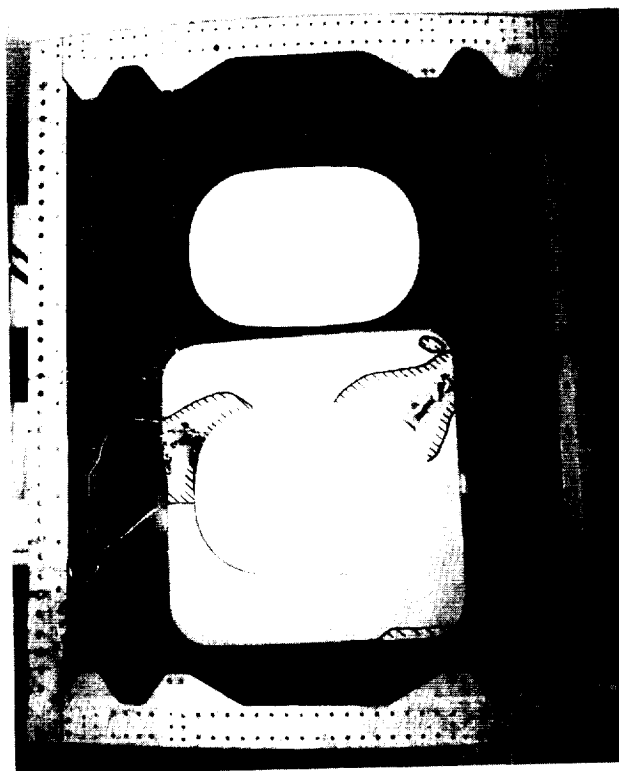
Figure 5-50. Group D Window Belt Panel — Areas of Skin Damage Detected by NDI
